BULLETIN 676

# 10-YEAR PAINT TESTS ON WEATHERED GALVANIZED ROOFING

By A. J. Muehling and J. O. Curtis

UNIVERSITY OF ILLINOIS  
AGRICULTURAL EXPERIMENT STATION

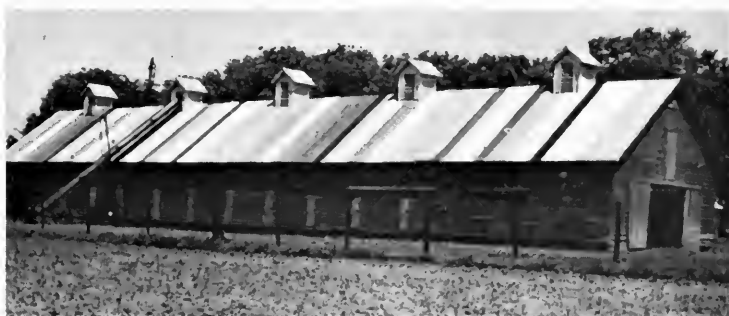
COVER PHOTO — the 150-foot corn crib on which the paint study was conducted (south side after application of first coat of paint).

The roof of a 150-foot crib on one of the University-owned Allerton farms near Monticello, Illinois, was chosen for the tests (see cover photo). The rural location corresponded to the least severe ordinary exposure condition, according to the classification of atmospheric types used by the American Society for Testing Materials (11). The condition of the galvanized sheets on this roof did not vary as much as the condition of the sheets used in the Harwood Tests. Much of the metal was quite rusty. A trace of black asphalt paint remained on most sheets from a previous painting. These surface conditions were as severe as one would be likely to encounter in farm buildings.

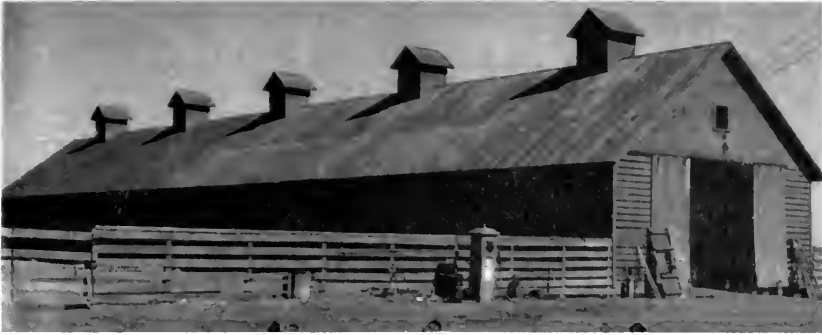
North side of crib before painting. The one-third of the roof at the left (Panels 46 through 81) was 100 percent rusty. (Fig. 2)

Excellent colored slides showing the original condition of the panels were taken before the tests began. These slides were studied and the amount of rust on each panel was recorded (see pages 16 to 18). The condition of the panels before painting can be seen in Fig. 2.

The top portions of the bottom sheets of Panels 46 through 81 on the north side were wire brushed before painting. These panels were 100 percent rusty (see Fig. 2). (Fig. 10)

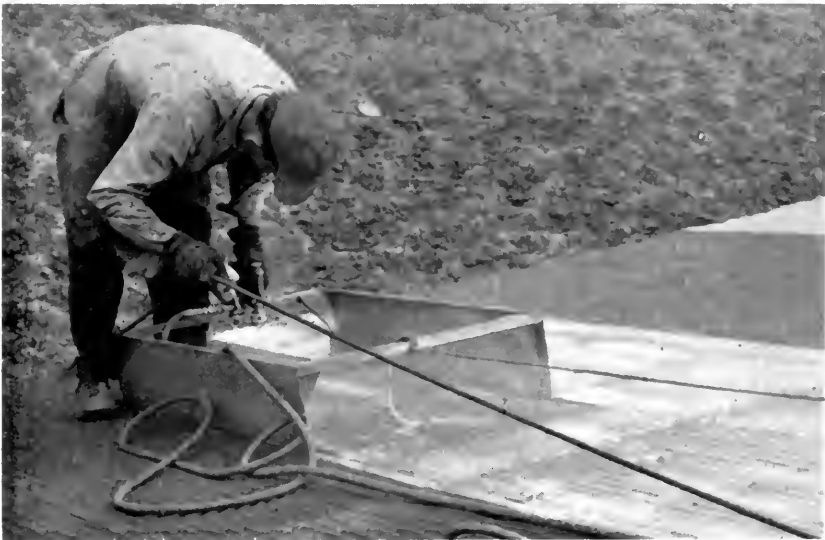
An aluminum shield was used to prevent spray from blowing to adjacent panels. (Fig. 3)

The paint coatings were applied with a small (0.203 gallon) DeVilbiss pressure cup unit. An aluminum shield was used to prevent the spray from blowing to adjacent panels (Fig. 3). The sprayer cup was cleaned after each application except when the same paint was applied to successive panels. Panels that were to have the same paint were grouped together to reduce the time and labor required for washing the cup and maneuvering the shield.
